PHASE I ENVIRONMENTAL SITE ASSESSMENT

**CITY OF GARDEN GROVE
PARCELS 1, 6-15 BROOKHURST TRIANGLE
GARDEN GROVE, CALIFORNIA**

DATED: OCTOBER 2004

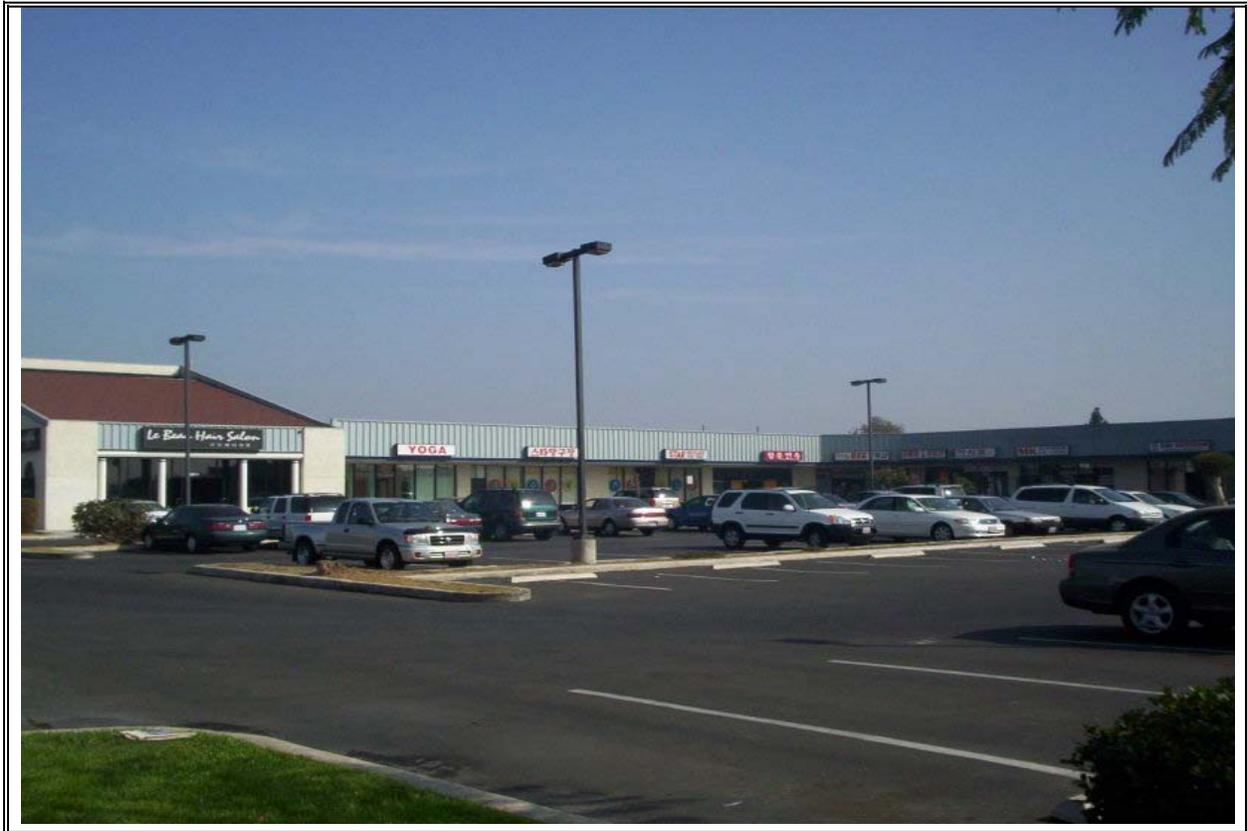
SUBJECT SITE - OP01

CONDITION # 2		IDENTIFIED LOCATION APPEARS TO BE A POTENTIAL OR POSSIBLE ENVIRONMENTAL CONDITION	
ID #	SECTION #	PAGE #	COMMENTS
OP01	3.1	3-1	Photograph of structure suspected of asbestos-containing materials.
SHS01	5.4.1	5-2	Observation of structures suspected of asbestos-containing materials.
<p>DESCRIPTION OF CONDITION: During the site reconnaissance, materials were identified that are suspected of containing asbestos. (See Section 5.4.2 for a complete list of suspect materials.) No samples of the suspect materials were taken. At the time of inspection, all of the materials appeared to be intact and undisturbed (that is, they appeared to be in a non-friable condition) and, thus, may not pose an immediate environmental concern. Still, these materials may become hazardous if they in fact contain asbestos and are subsequently damaged or disturbed, as, for example, in the course of remodeling. Asbestos-containing materials are considered to be hazardous materials, and their eventual disposal and handling are subject to federal and state regulatory guidelines.</p>

<p>ACTION SUGGESTED: Prior to disturbing the suspected asbestos-containing materials, such as during remodeling or demolition, contact PHASE ONE INC. or another asbestos consultant for sampling and analysis of the suspect materials. If samples test positive, develop an Operations and Maintenance (O&M) Plan detailing the material-handling procedures to be implemented.</p>
