# City of Garden Grove Infrastructure Space Needs Assessment Report

January 14, 2020

Submitted by:  
Dewberry  
300 N. Lake Ave  
Pasadena Ca, 91101  
916.239.7247

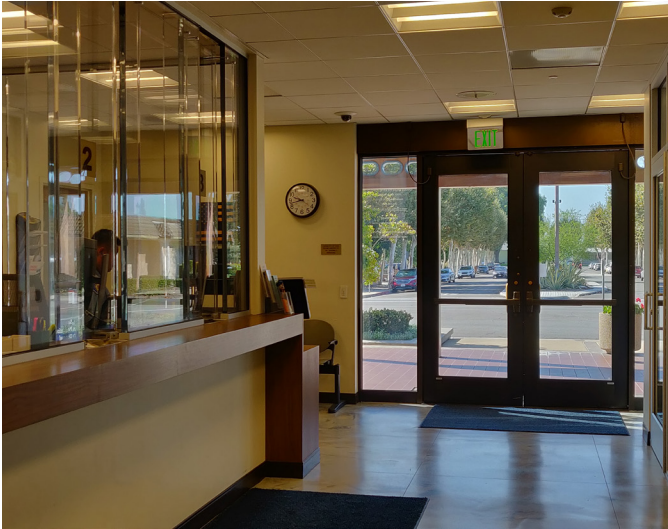
Public Lobby

- Inadequate storage spaces and no room for staff growth
- Inadequate office space for staff
- Public Lobby:
  - No ADA accessible elevator from the public lobby to get up to the 2nd floor administration division
  - No ADA Record's counter
  - Do not have waiting area for families or soft interview rooms
- Records:
  - Need larger Record Writing Room, when there are more than one officers or family comes in.

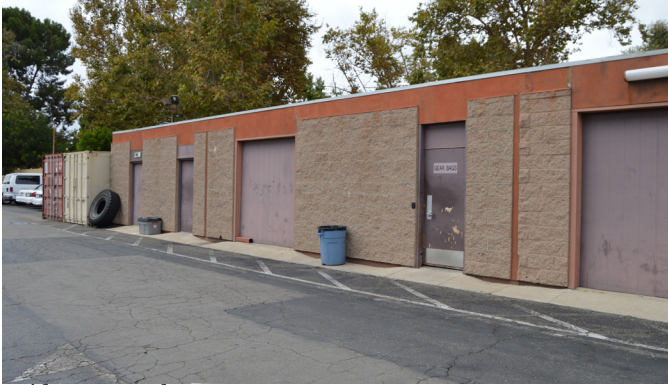
Evidence Warehouse

- Inadequate office and storage spaces
- No room for staff growth
- Inadequate ventilation for narcotic storage
- Inadequate space for evidence processing
- No proper vehicle processing bay separation from other areas
- Fitness room is not adequate for the large number of staff.
- Fitness room needs proper ventilation
- Inadequate number of duty bag shelving for officers and no room to add additional shelving.

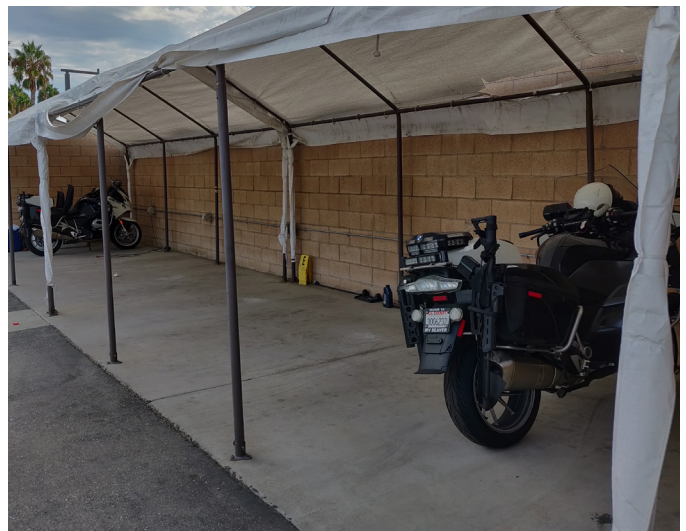
Motorcycle Storage

- Inadequate office and storage spaces
- No room for staff growth
- Non-secured building
- Non-Secured parking for motorcycle
- Reception in Gang and Special Investigation Unit does not have ballistic protection
- Interview rooms picks up outside noise and inadequate audio and visual recording
- SWAT equipment is kept in connex box, which is subject to weather
- Lacks secured armory storage with climate control
- Lacks indoor parking for vehicles like, Mine-Resistant Ambush Protected (MRAP), Bear Cub, Command Post, and Suburbans Plus vehicles.
- Lacks rooms for SWAT officers

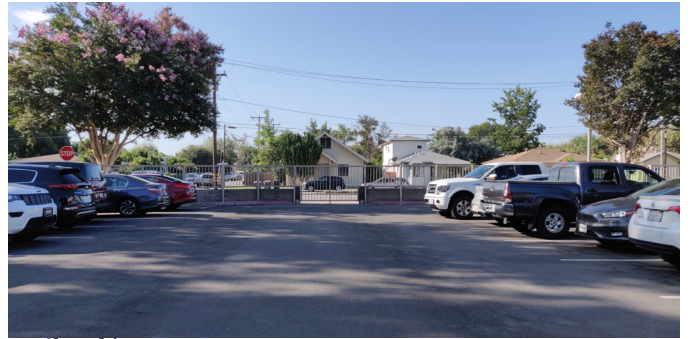
Staff Parking

- Not enough staff parking
- Not enough public parking
- Not enough ADA parking stalls
- Staff parking is not secured
- Limited perimeter security
- Lacks indoor garage storage and parking

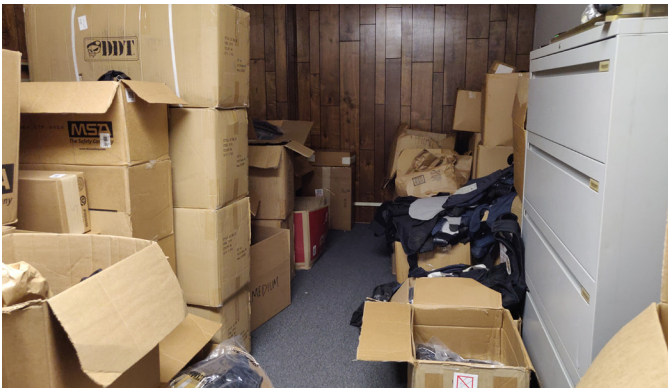
Supplies Storage

- Inadequate storage spaces
- No room for staff growth
- Building is on lease
- Inefficient use of current volume / height for evidence storage
- Minimally secured facility
- Off-site facility requires vehicular transport
- The warehouse had roof leaks and water damage

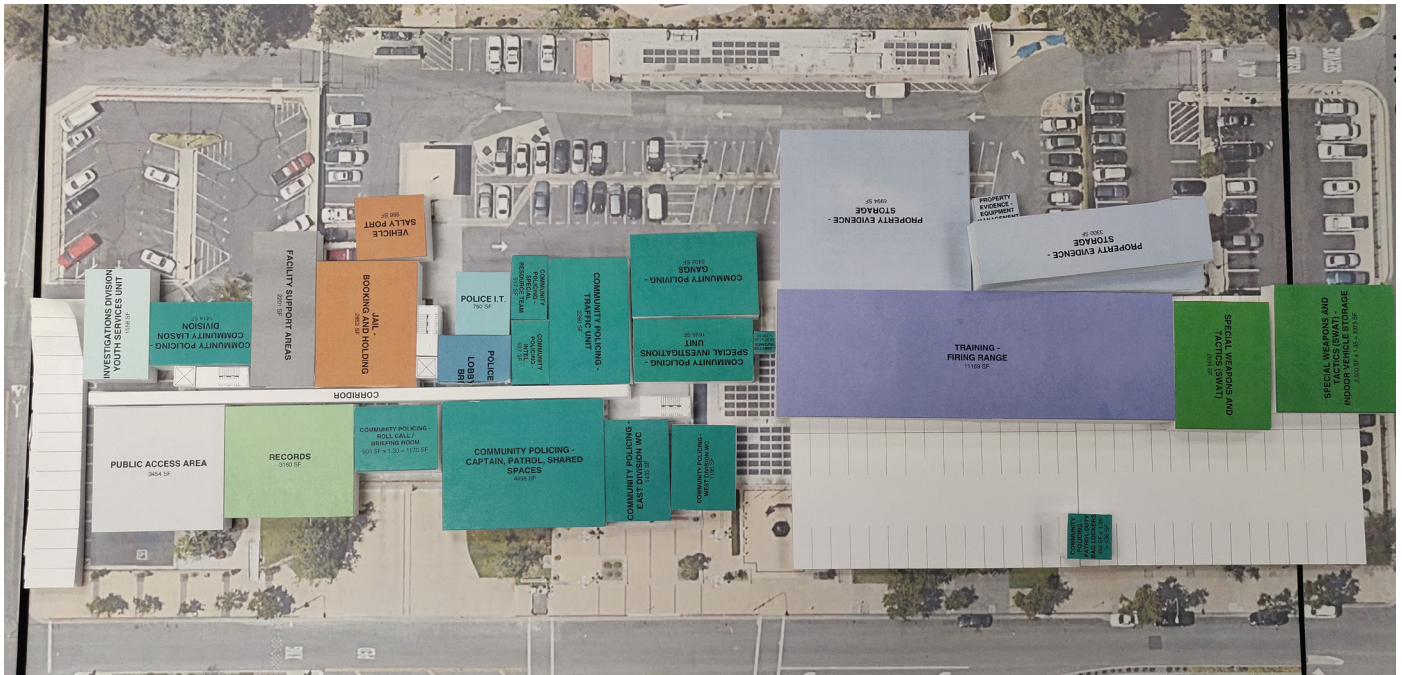
Below is an image of option explored with the idea of replacing the existing police facilities at it's current location. The design team have decided not to further pursue this design option due to the difficulty of construction phasing and the potential of multiple staff, equipment, and property evidence relocation. Large scale plans are located in the Appendix.

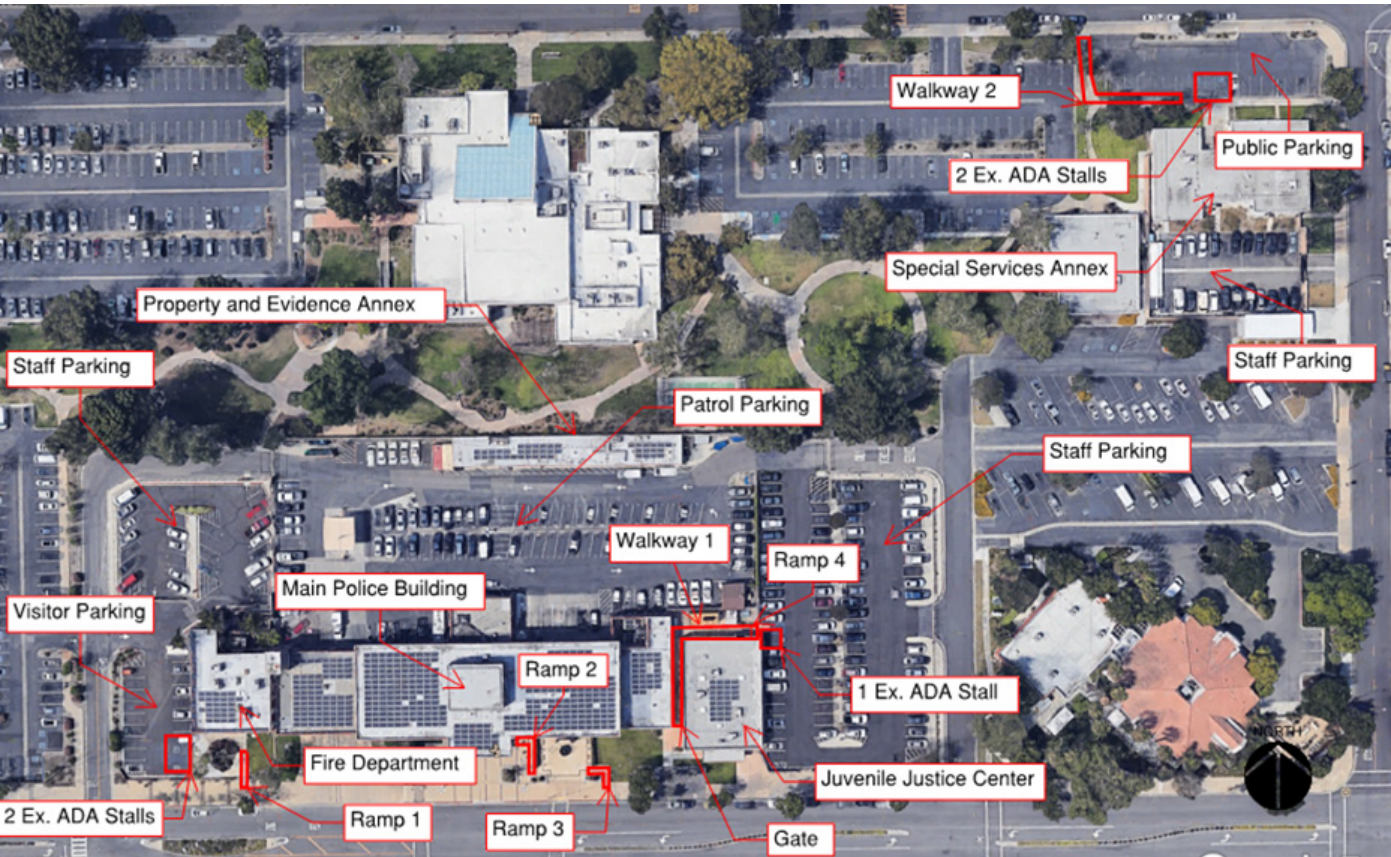
The site evaluation was based on visual observation, tape measurements, and the use of a digital leveler to measure site slopes. The main ADA issues observed were the lack of ADA parking stalls and van accessible stalls, non-compliant pedestrian walkways/ ramps; non-compliant curb ramps; non-compliant concrete and asphalt surface slopes; non-compliant ADA parking stall dimensions, and non-compliant signage.

A detailed accessibility assessment with a reference map and photos of each observed areas is provided below.

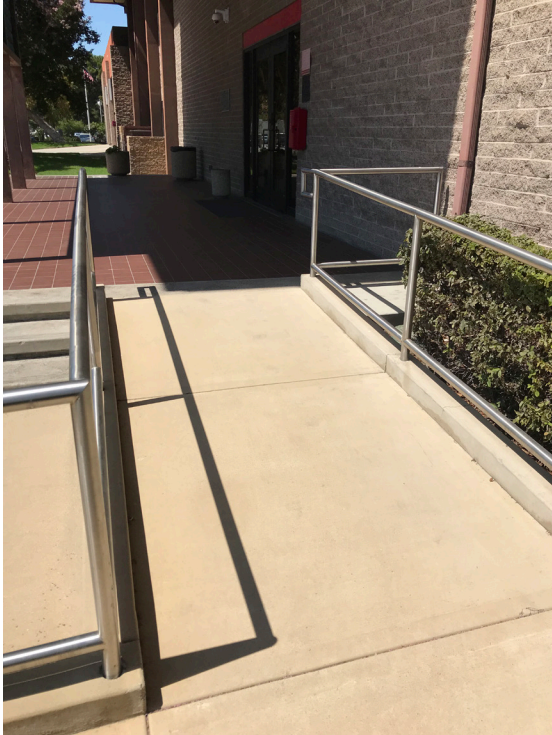
Photo 1

Item No.	Location	Location Description	Picture Ref.	Issue	2019 CBC Ref.	Remarks/ Recommendation
1	Main Police Building	Accessible Ramp #2	1	Top section of ramp running slope is 9%. Ramps shall have a running slope not greater than 1:12 (8.33%).	CBC 11B-405.2	Reconstruct to a code compliant ramp.
2	Main Police Building	Entire Parking Lot	N/A	There are no ADA parking stalls present or path of travel in the parking lot north of the building.	CBC 11B-208	Provide a total of 4 accessible parking stalls which includes 1 van accessible stall. Provide accessible path of travel which may include accessible walkways, ramps, and curb ramps.
3	Property and Evidence Annex	Entire Parking Lot	N/A	An accessible path of travel between the Main Police Building and the Property and Evidence Annex is not provided. No ADA stalls are provided for the shared parking lot between the main police building and the Property and Evidence Annex. (See Item No. 2)	CBC 11B-208	Provide accessible parking stalls in Item 2 above and path of travel to comply which may include accessible walkways, ramps, and curb ramps.

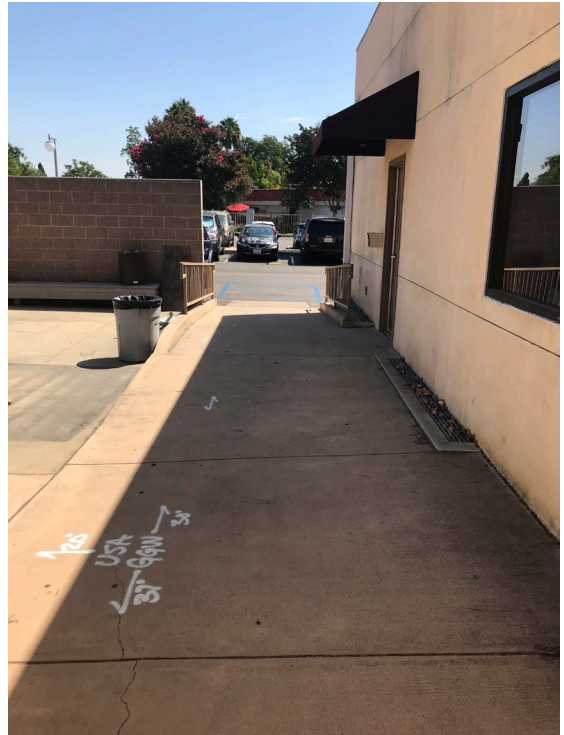
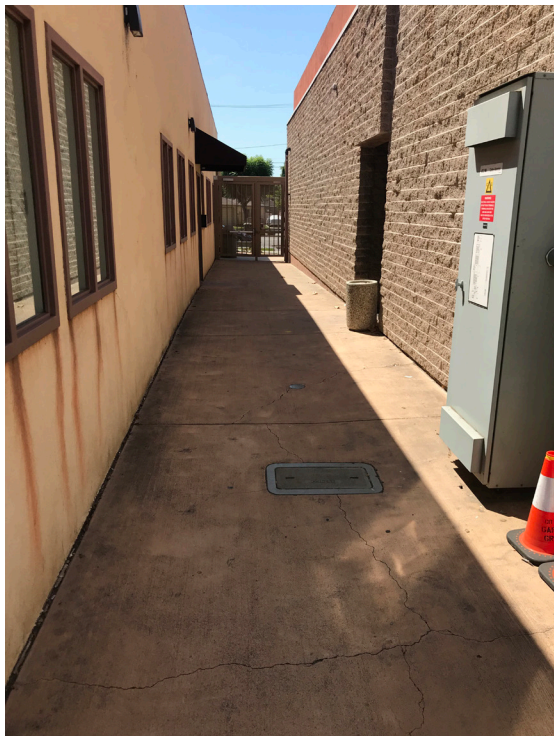
Photo 14

10	Juvenile Justice Center	Pedestrian Walkways on the north and west sides of the building	14-15	The cross slope of the existing walkway is 3%. The cross slope of walking surfaces shall not be greater than 1:48 (2.08%).	CBC 11B-502.4	Reconstruct existing walkways.
11	Juvenile Justice Center	Door on west side of building	16	Existing threshold is 2 inches. Code allowable maximum threshold is 0.5 inches.	CBC 11B-404.2.5 11B-302.303	Reconstruct existing walkway and replace threshold.
12	Special Services Annex	Parking Lot on the south side of building	N/A	There are no ADA parking stalls present or path of travel in the parking lot south of the building.	CBC 11B-208	Provide 1 van accessible parking stall and path of travel to comply which may include accessible walkways, ramps, and curb ramps. .
13	Special Services Annex	North Parking Lot Accessible Parking Space (both parking spaces)	17-18	Existing striping is faded. Existing asphalt pavement is in poor condition.	CBC 11B-108	Remove and replace asphalt pavement and restripe.

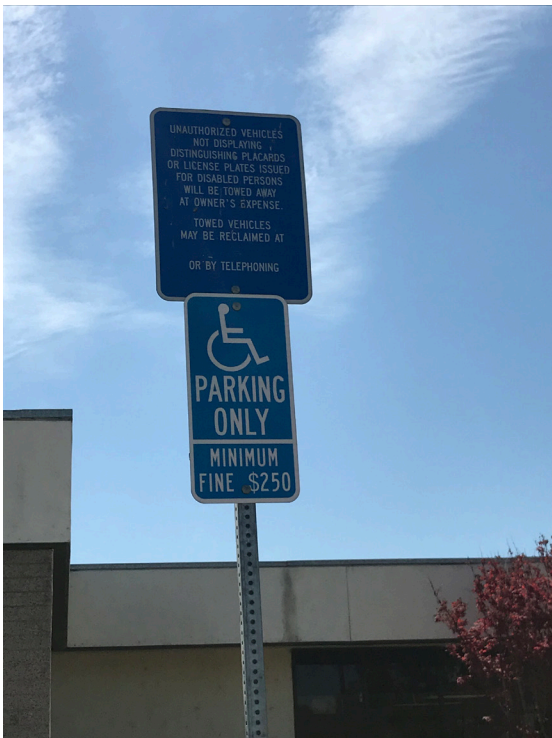
Photo 19

14	Special Services Annex	North Parking Lot Accessible Parking Space (both parking spaces)	18-19	Existing accessible identification signs are not code compliant. Existing sign for the stall to the west is not at code required height.	CBC 11B-502.6 11B-502.8.2	Replace Signs.
16	Special Services Annex	North Parking Lot Existing Curb Ramp	18	Code required truncated domes are not provided.	CBC 11B-705.1	Install truncated domes.
17	Special Services Annex	Pedestrian Walkway from Stanford Avenue to Building	20-21	Slope of the walkway south of Stanford Avenue sidewalk is greater than 5%. Few sections of the existing walkway are lifted.	CBC 11B-405.2	Reconstruct existing walkway.
